Ord.code: FMS037-H01PO

Installation bracket of the Hub to the seat Politecnica Transeurope **Express**

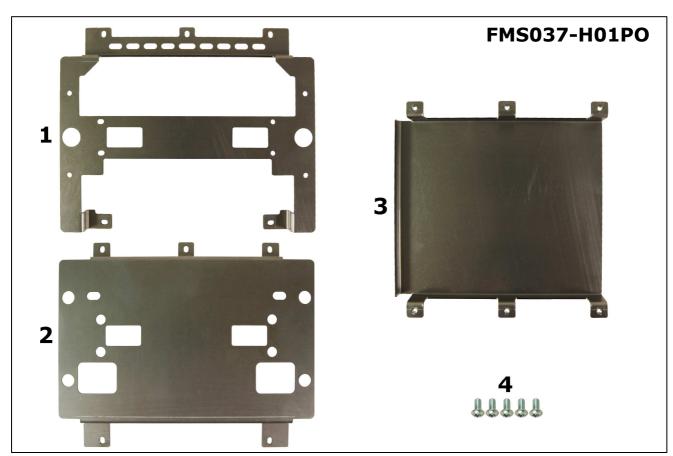
Chart N.1

Material needed for installation

Pos.1	Name	Code	Pcs
1	Bracket of the Hub of the seat Politecnica Transeurope	0810346-M/1	1
2	Top cover of the Hub of the seat Politecnica Transeurope	0810402-M/1	1
3	Cover of the Hub of the seat Politecnica Transeurope Express	0810347-M/1	1
4	Screw M4x8mm with half-rounded head Torx	104BN6404M4x8	5

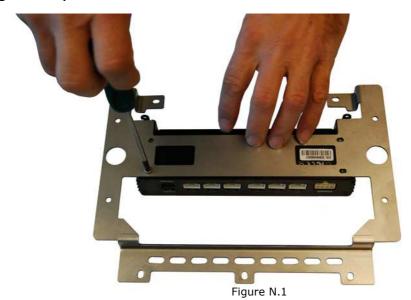
1 - Before the installation of the Hub unscrew 4 screws, that are fixing the supports on Hub, remove the supports and with the original unmounted screws fix from bottom part of the bracket 0810346-M/1 (Chart N.1, pos.N.1) Hub (according figure N.1).

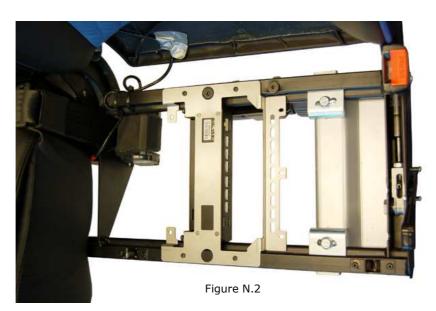
2 - Put mounted kit on the frame of the seat (according figure N.2)

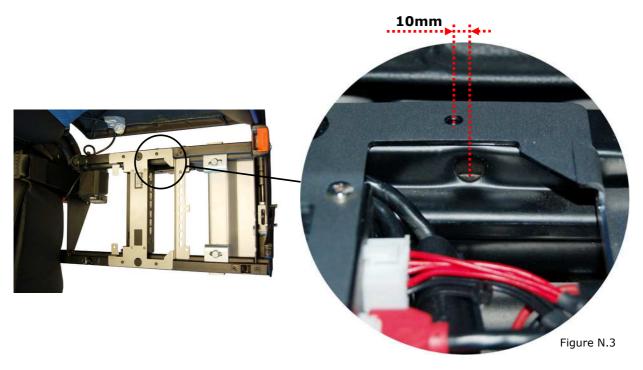
3 - Kit in frame of the seat move to such position, so the next hole for screw (marked with circle) will be from fixing point in frame of the seat far 10 mm in the direction to middle lengthways axis of the bus (according figure N.3).

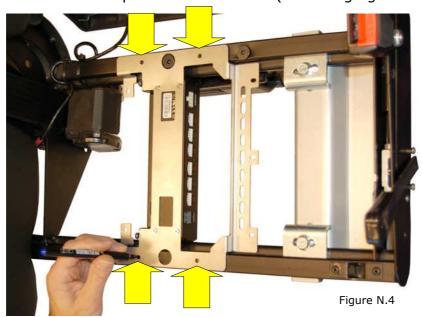
4 - Mark the 4 holes in the points of the arrows (according figure N.4)

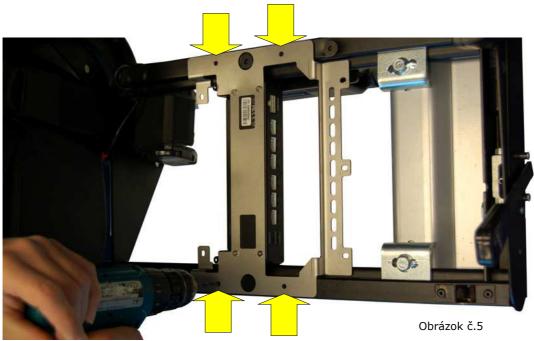
5 - Drill with the drilling machine(drill Ø3,5mm) into the main frame of the seat 4 holes and with them fix the kit with self-tapping screws 4,2mm (in marked points according the picture N.5).

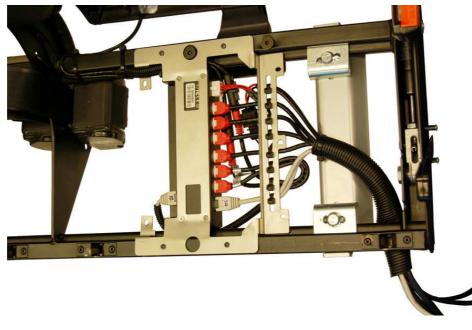
Figure N.6

In this point we connect to Hub all needed cable inteconnections and properly attach them to bracket with tightening straps.

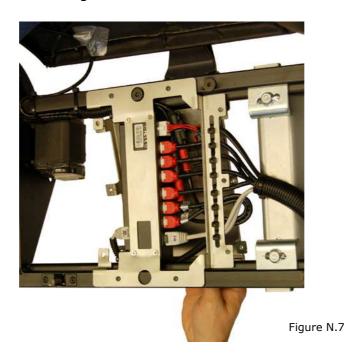
- 6 Cover of the Hub-u 0810347-M/1 (chart N.1, pos.N.3) lay from the bottom side to already mounted kit on the seat.
- 7 Space between the bracket and the cover of the Hub use for placing of the cable connections and cabling.

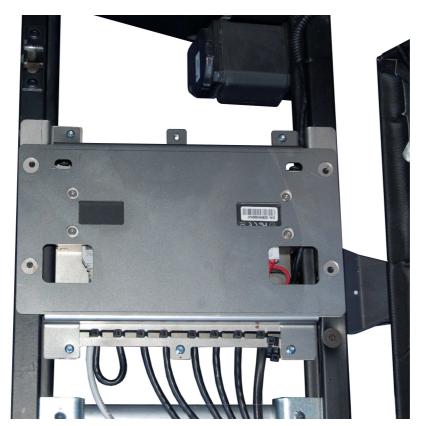
Figure N.9

9 -The result of the assembly is assembled kit.
